MASON PARK WETLAND MANAGEMENT PLAN

DECEMBER 2021

Project Title	MASON PARK WETLANDS MANAGEMENT PLAN
Client	Strathfield Council
Client contact	WHITNEY-MAY LEVER

Mason Park Wetlands – Review of Hydrology

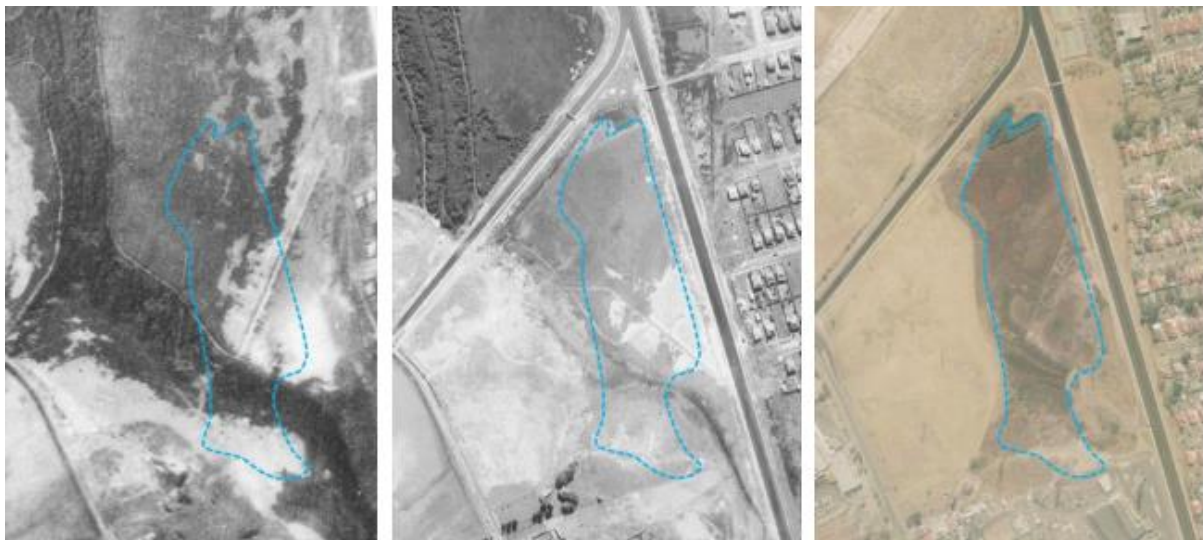
Figure 2 Historic aerial imagery of Mason Park Wetlands, 1930 (left), 1951 (middle), 1986 (right), blue line shows current extent 2021

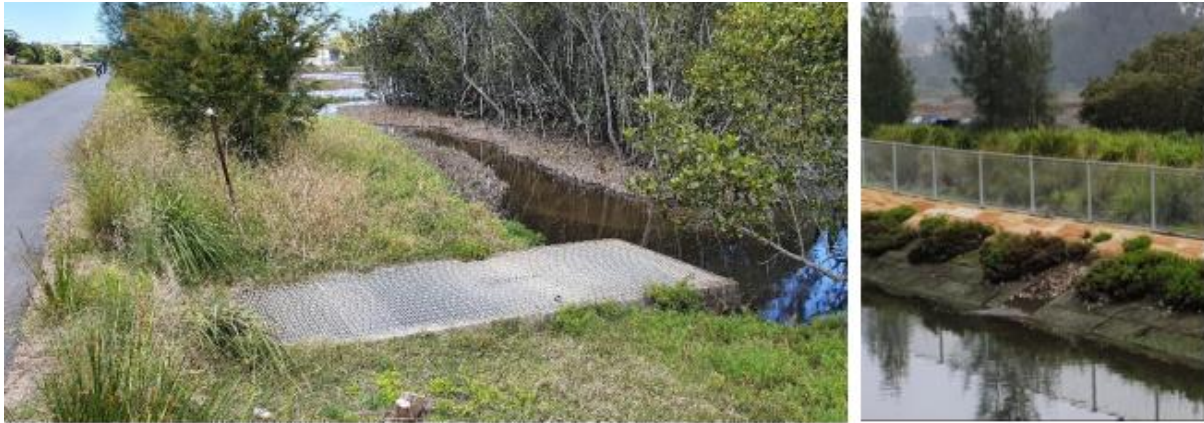
Figure 7 Existing inlet/outlet structure, at wetlands (L), grate over culvert on Powells Creek side (R)

The inlet structure was upgraded around 2009 to its current configuration. The aim was to increase the size of the connection and install two ‘flap gates’, with each flap over a 450mm diameter penetration. The flap gates are fitted with hinges such that water can enter the wetlands during a high tide, if the water level in the wetlands is lower than the high tide level. The indicative diagram in Figure 8 shows flow into the wetlands occurring when the water level in Powells Creek is higher than the water level in the wetlands.

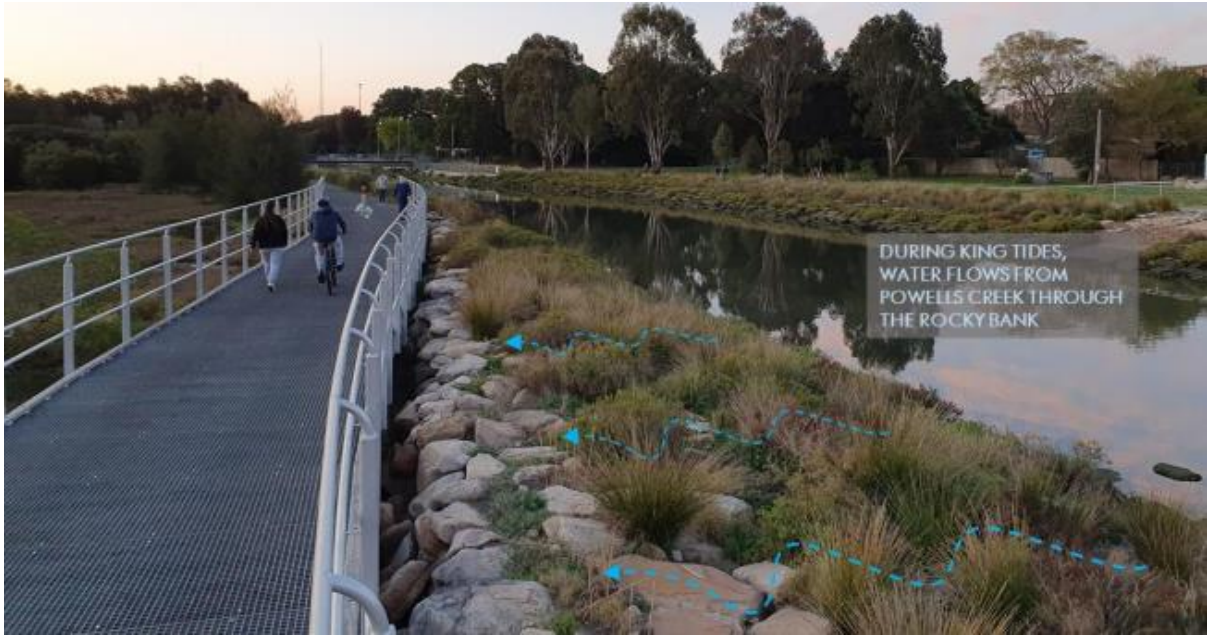
Figure 11 Powells Creek naturalised edge, looking north, with indicative flows

In 2018, Sydney Water conducted creek bank naturalisation works where the existing concrete channel walls of Powells Creek were removed and replaced with sandstone boulders and native plants (Figure 11). The naturalised edge introduced a new source of tidal water input to Mason Park through the eastern boundary. The naturalised bank was constructed using sandstone pieces which are permeable and act as a ‘leaky’ wall, enabling water to travel into the wetland when the tides are high enough, as shown in Figure 10.

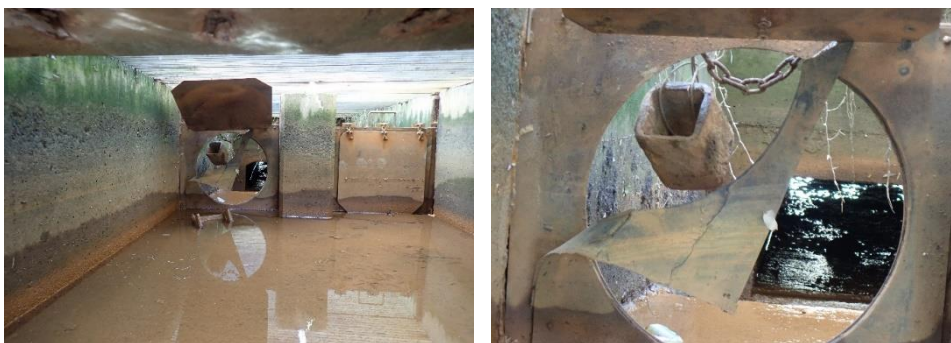
Figure 12 (left) in and outflows can be regulated with floodgates; (right) the floodgates are rusty and have fallen into disrepair

This was later replaced in 2010 with a new weir floodgate that opens to allow water in at higher tides (in response to water pressure), and remains closed to keep water in as the tides runs out (again in response to water pressure). The structure remains in place to date, but has rusted and the flow gates have become damaged.

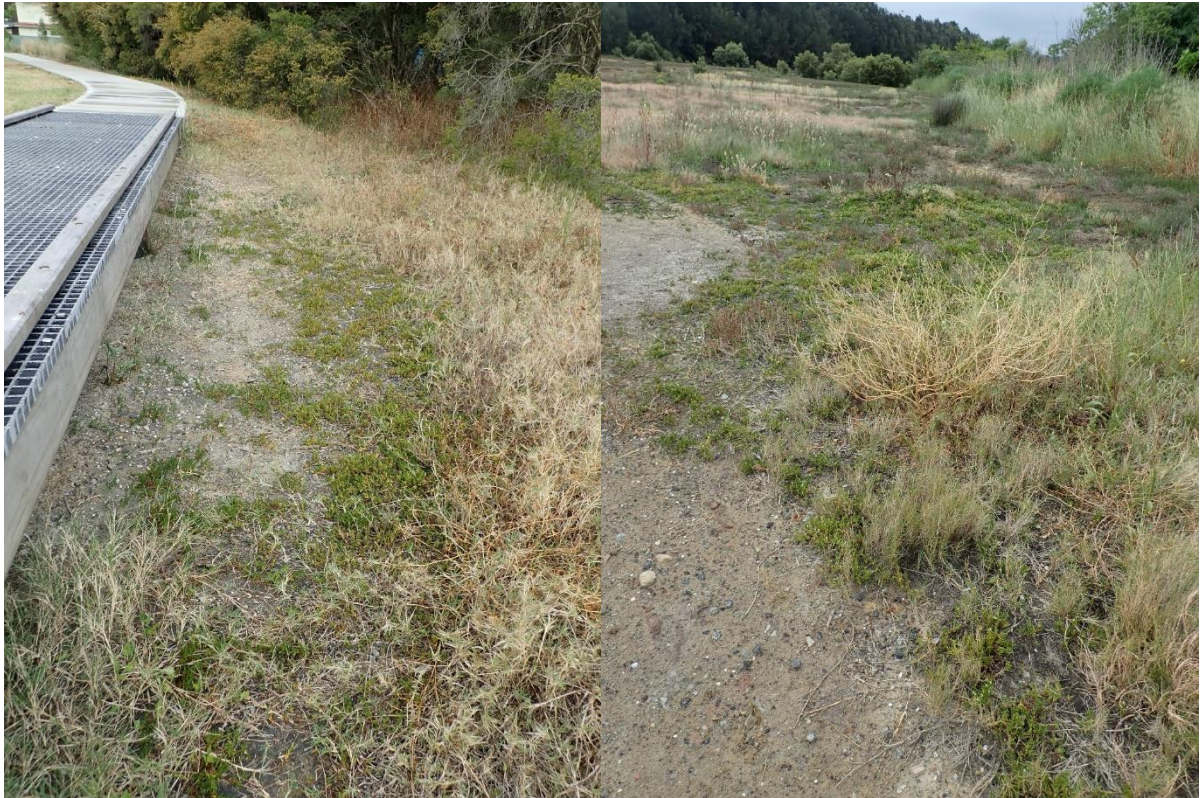
Figure 14 *Wilsonia backhousei* are damaged by trampling and vehicle use, and recovery from damage is slow

Mats of *Wilsonia backhousei* are damaged by trampling and vehicle use, and recovery from damage is slow (Figure 14). A boardwalk was recommended in 2008 and constructed 2017, and the apparent reduction in extent of *Wilsonia* may be attributable to the construction process. However, there are ongoing impacts from vehicle access, and the boardwalk only provides for pedestrians and cycles.

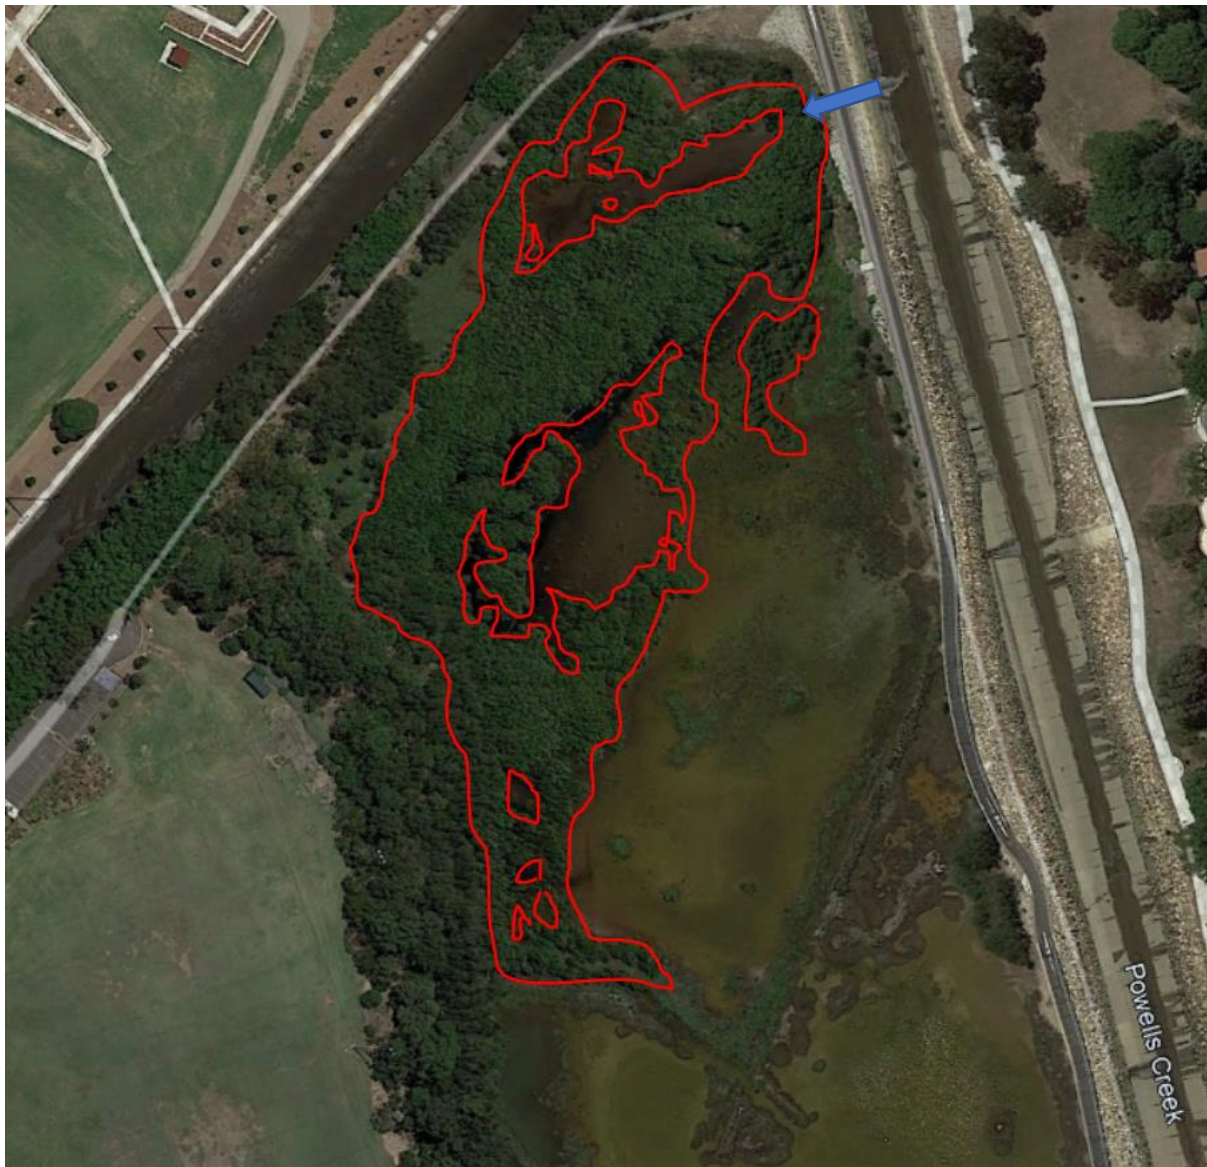
Figure 19 Mangroves have colonised the area around the inlet and spread from there across the northern end

Mangroves have colonised the area around the inlet, and spread from there across the northern end of the wetlands. Mangroves in Mason Park wetland do not fulfil their traditional roles within the estuary environment. The trend of mangrove encroachment into saltmarsh has been the dominant cause of saltmarsh decline in the Sydney basin (Saintilan and Williams, 2000). Mangrove encroachment is limited by periodicity of inundation, which is usually related to depth of inundation. As mangroves encroach into saltmarsh areas they tend to accumulate additional sediments which in turn raises the surface level of the wetland, favouring saltmarsh rather than mangroves. Mason Park, however, is not a typical wetland as the frequency and depth of inundation are determined by the inlet/outlet structure.

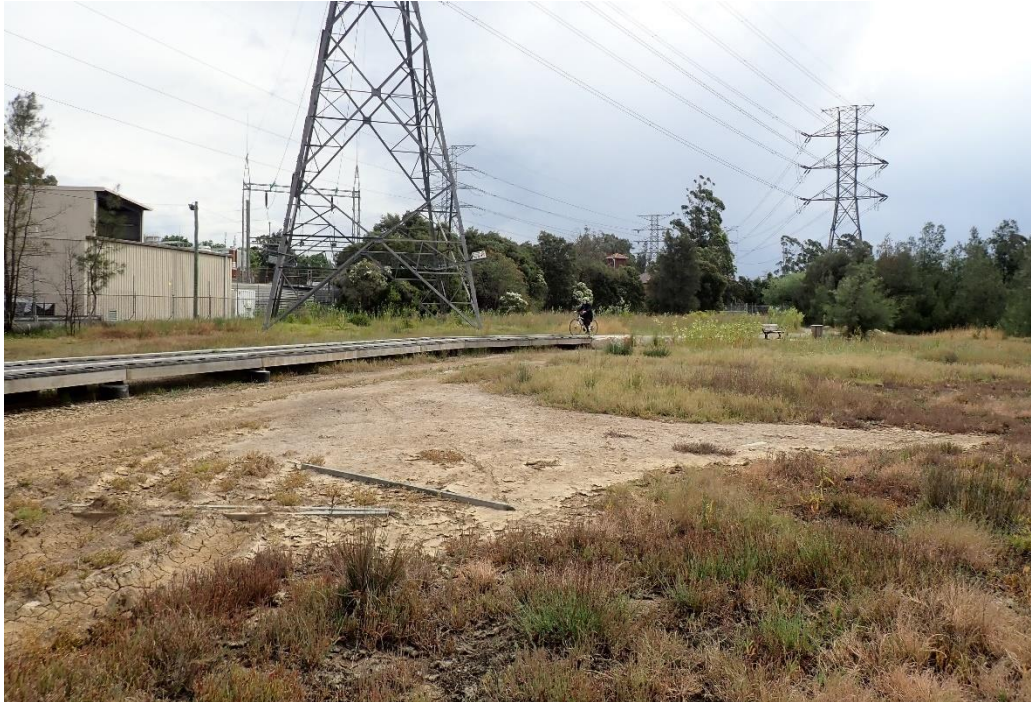
Figure 20 Damage to mudflats and areas of *Wilsonia backhousei* population by vehicles

- Damage from vehicles crossing mudflats where the core *Wilsonia backhousei* population used to exist (note: original damage may have occurred during the construction of the boardwalk crossing)

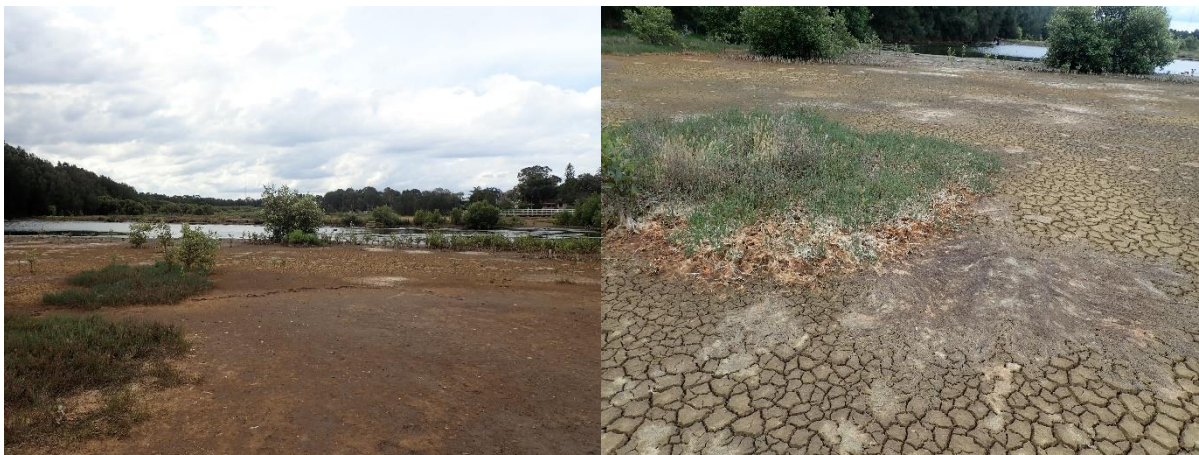
Figure 21 Large expanses of tidal flats are adversely impacted by poor management of the tidal regime

For the open mudflats to remain viable as shorebird habitat they must be regularly inundated. This keeps the microbenthic fauna alive, which provides the valuable food resources also needed by the migratory shorebirds. Without food, the wetlands lose a lot of their value for these species – many of which are subject to migratory species agreements with other countries. When the tidal flats are allowed to dry out completely (Figure 21) the result is a combination of hypersalinity, mobilisation followed by crystallization of toxic compounds in the soils, changes in pH, cracking of the surface, all of which contribute to the loss of infauna, with flow on impacts for saltmarsh species and the migratory shorebirds. Compaction following drying makes the process of reestablishment of macrobenthos almost impossible.

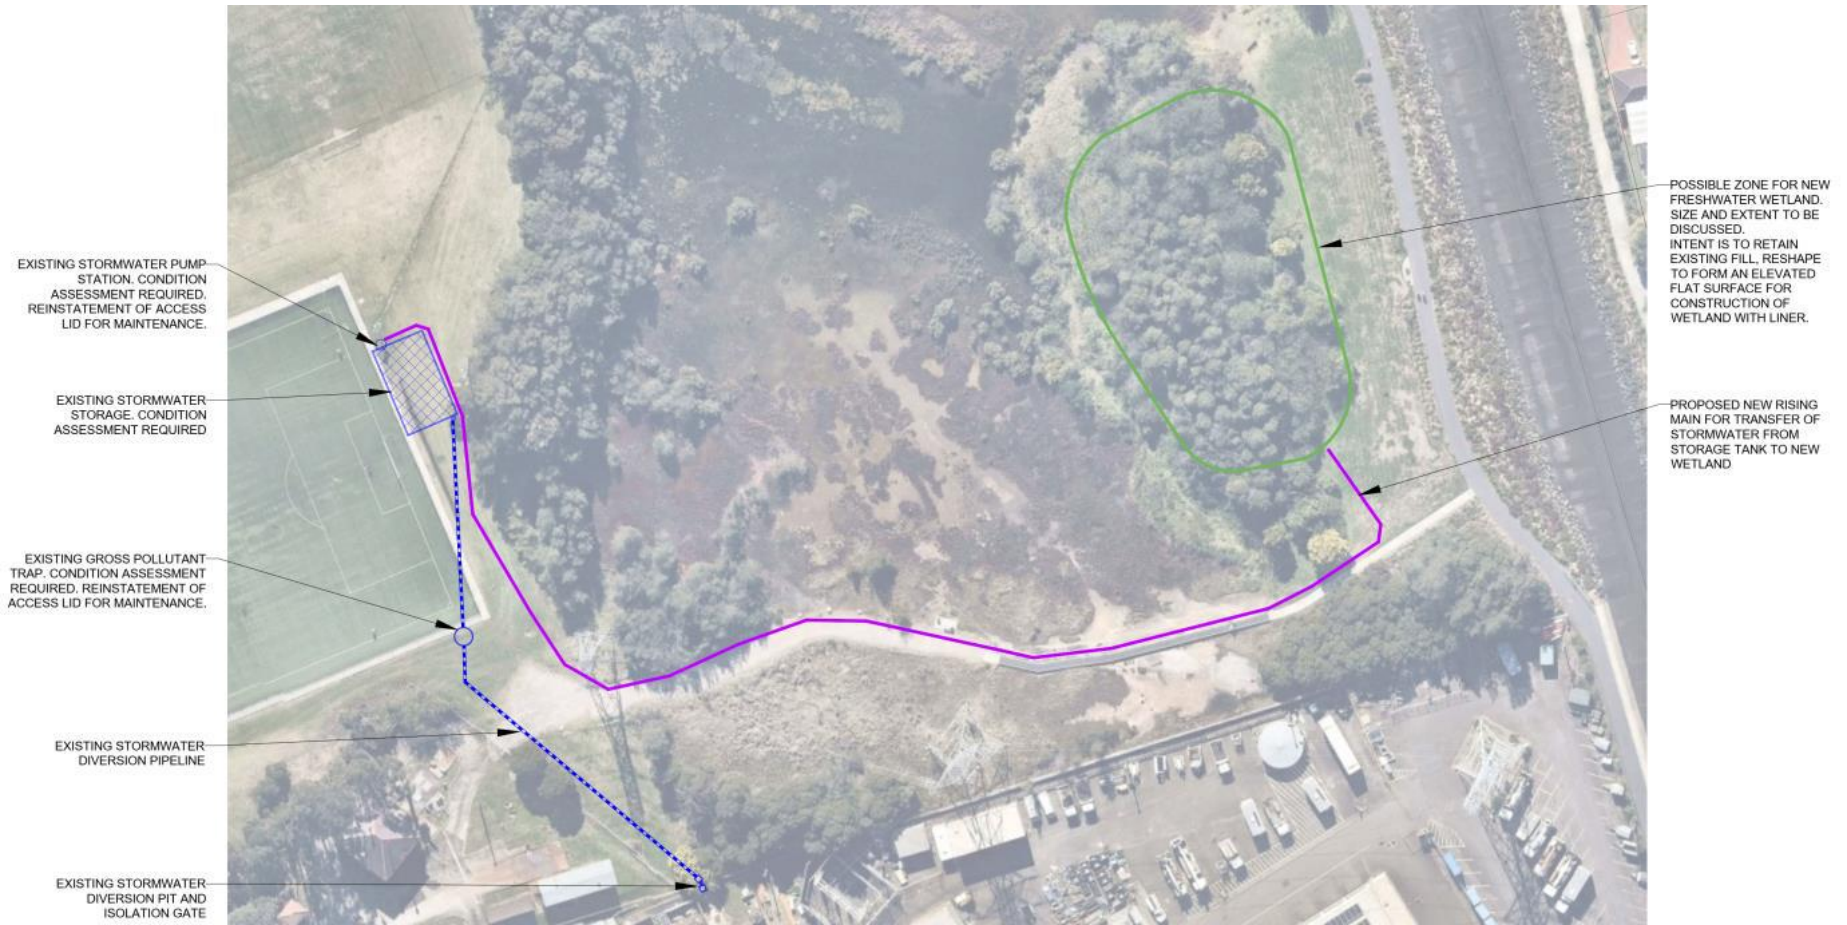
Figure 40 Indicative plan for new constructed wetland

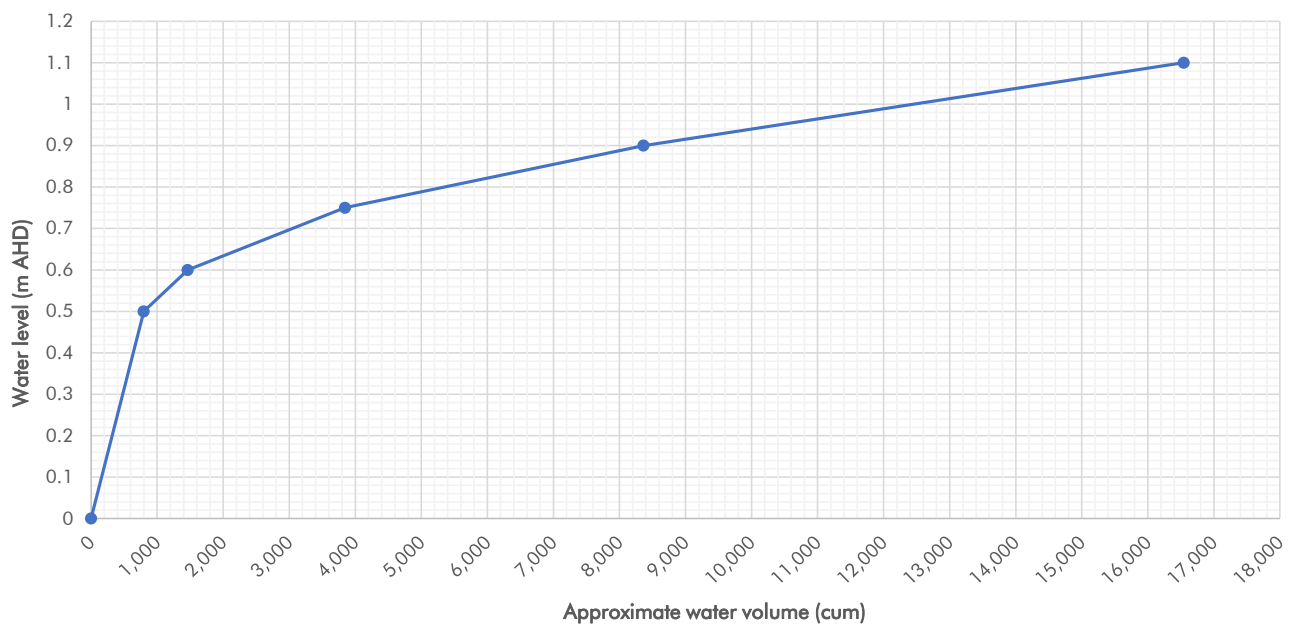
Figure 6 Wetlands approximate total stage-storage volume chart

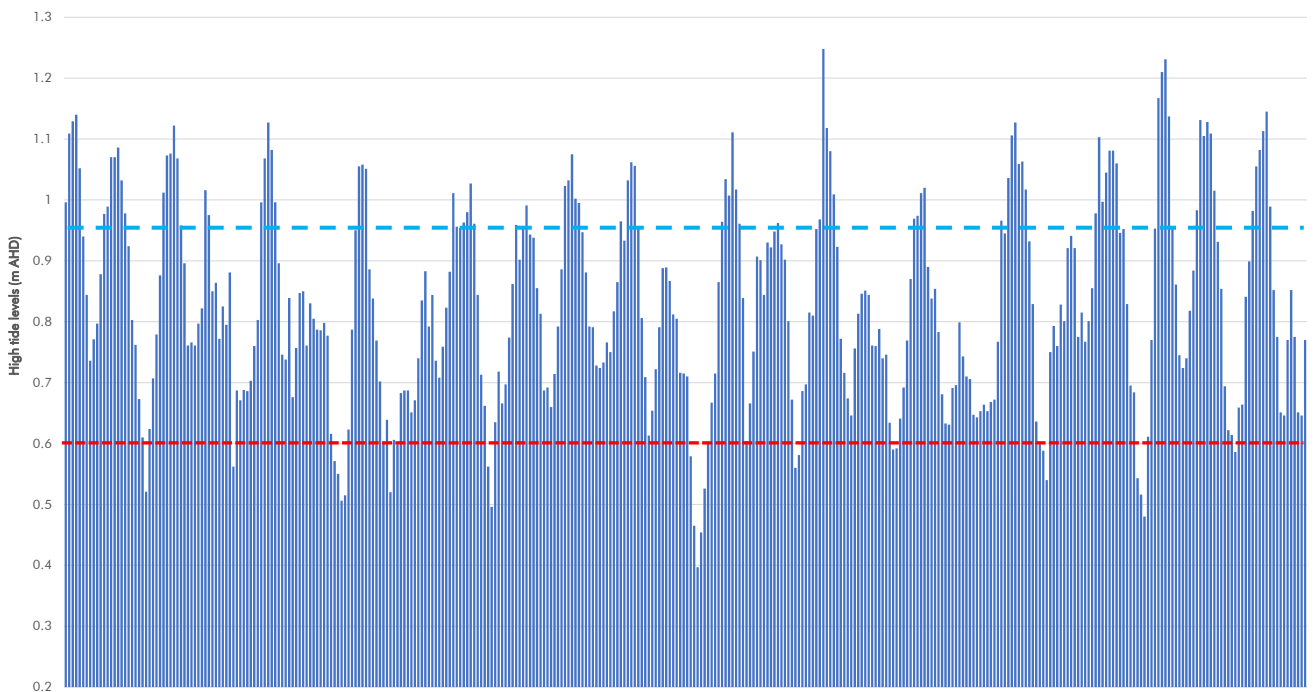
Figure 8 High tide levels in Powells Creek for 2019-2020, with nominal wetlands bed level (red dashed line) and 'full standing water level' (blue dashed line)

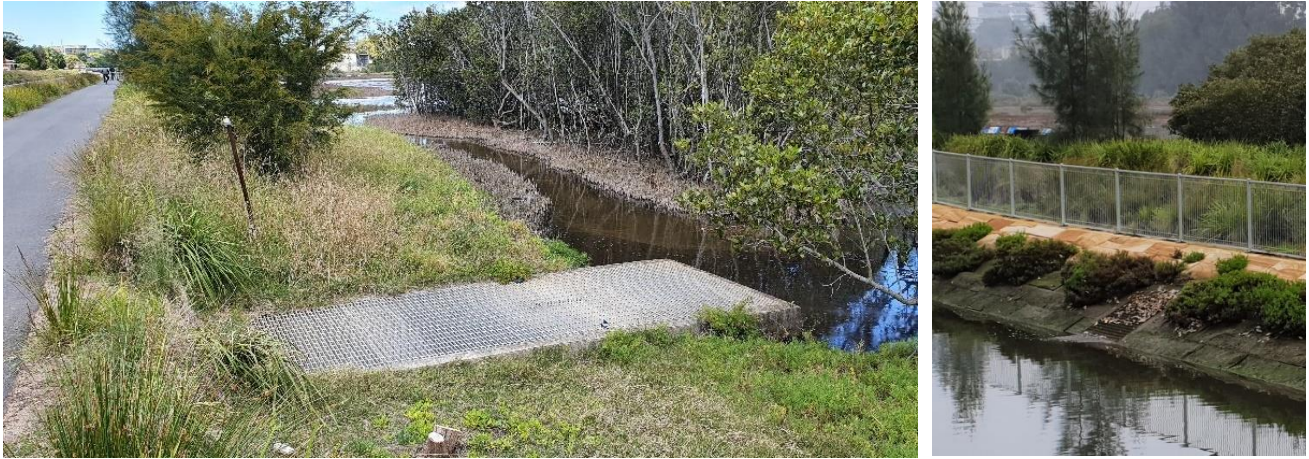
Figure 11 Existing inlet/outlet structure, at wetlands (L), grate over culvert on Powells Creek side (R)

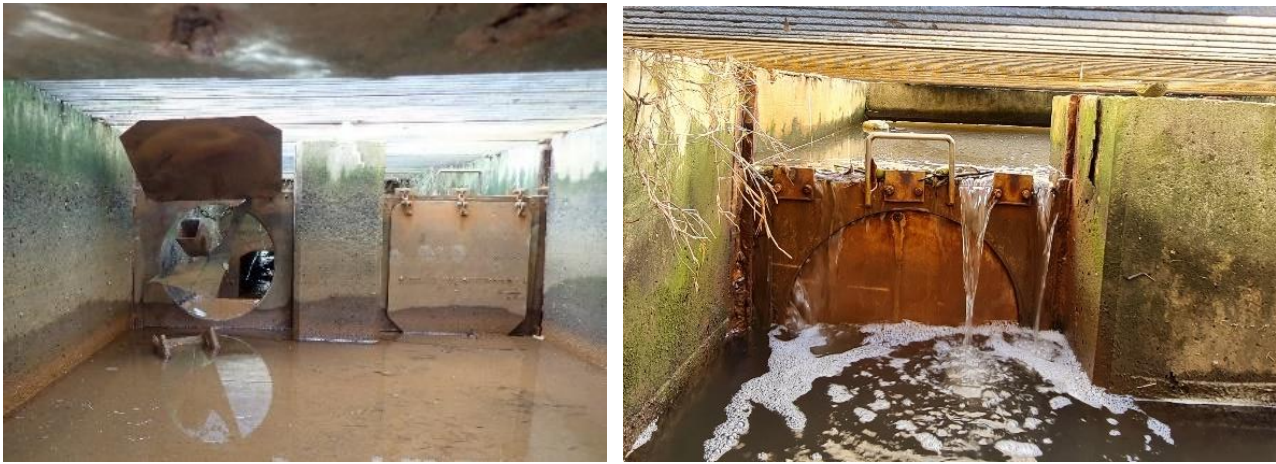
Figure 13 Internal view of inlet/outlet structure, looking from wetland side when drained (L), looking from Powells Creek side with water held in the wetlands (R)

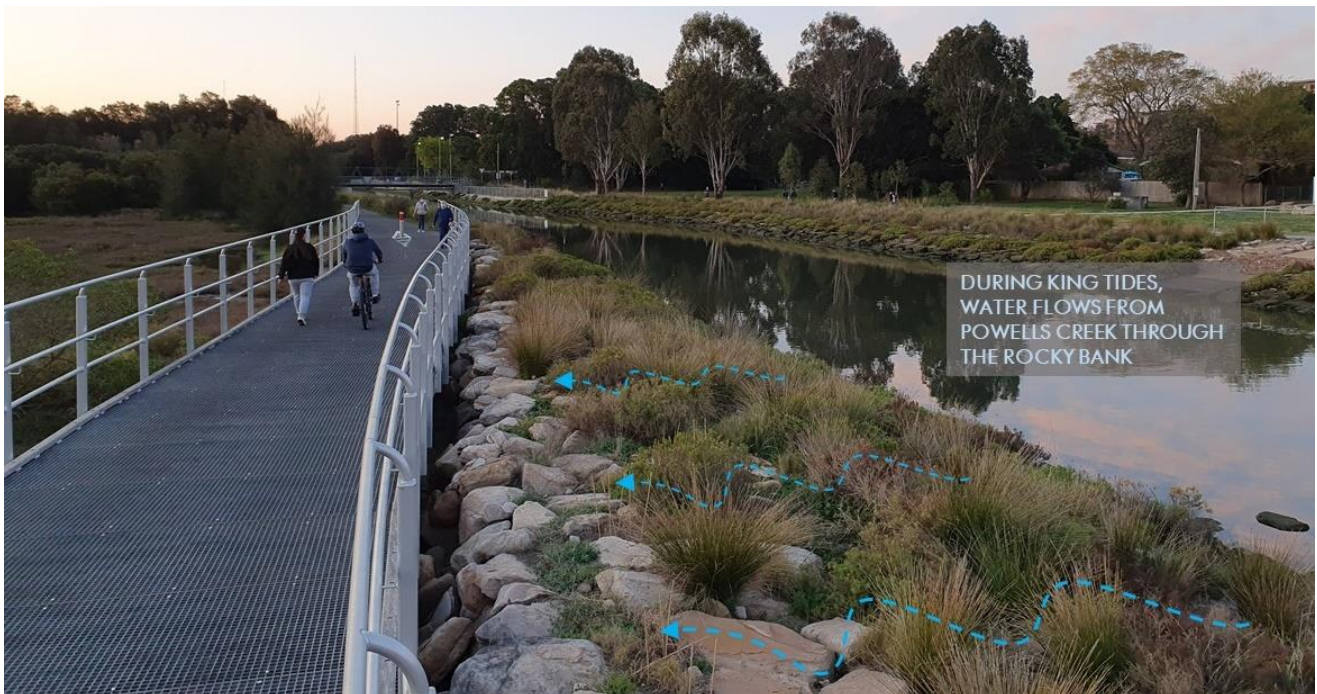
Figure 16 Powells Creek naturalised edge, looking north, with indicative flows

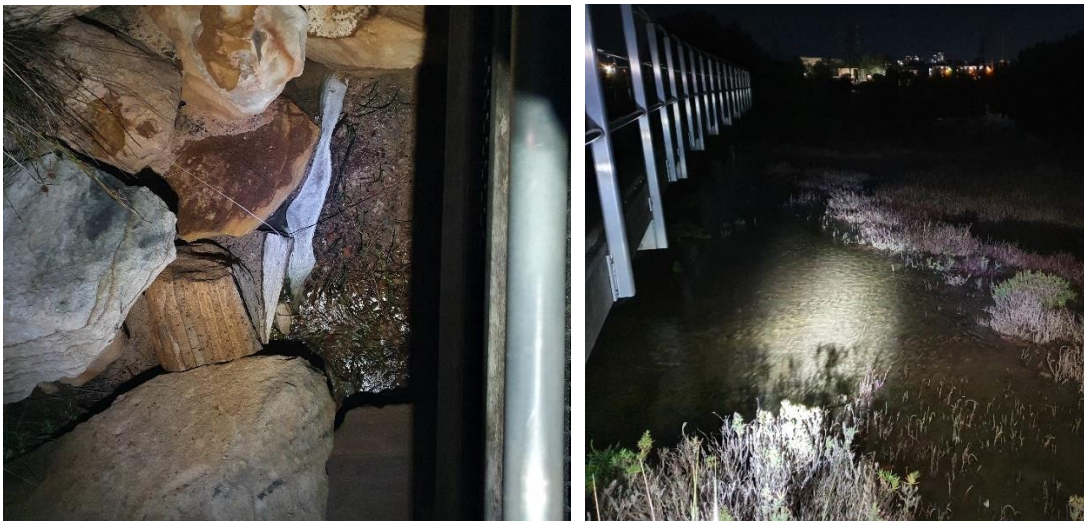
Figure 17 Water flowing into the wetlands during king tide via Sydney Water naturalised bank, looking south (June 2021)

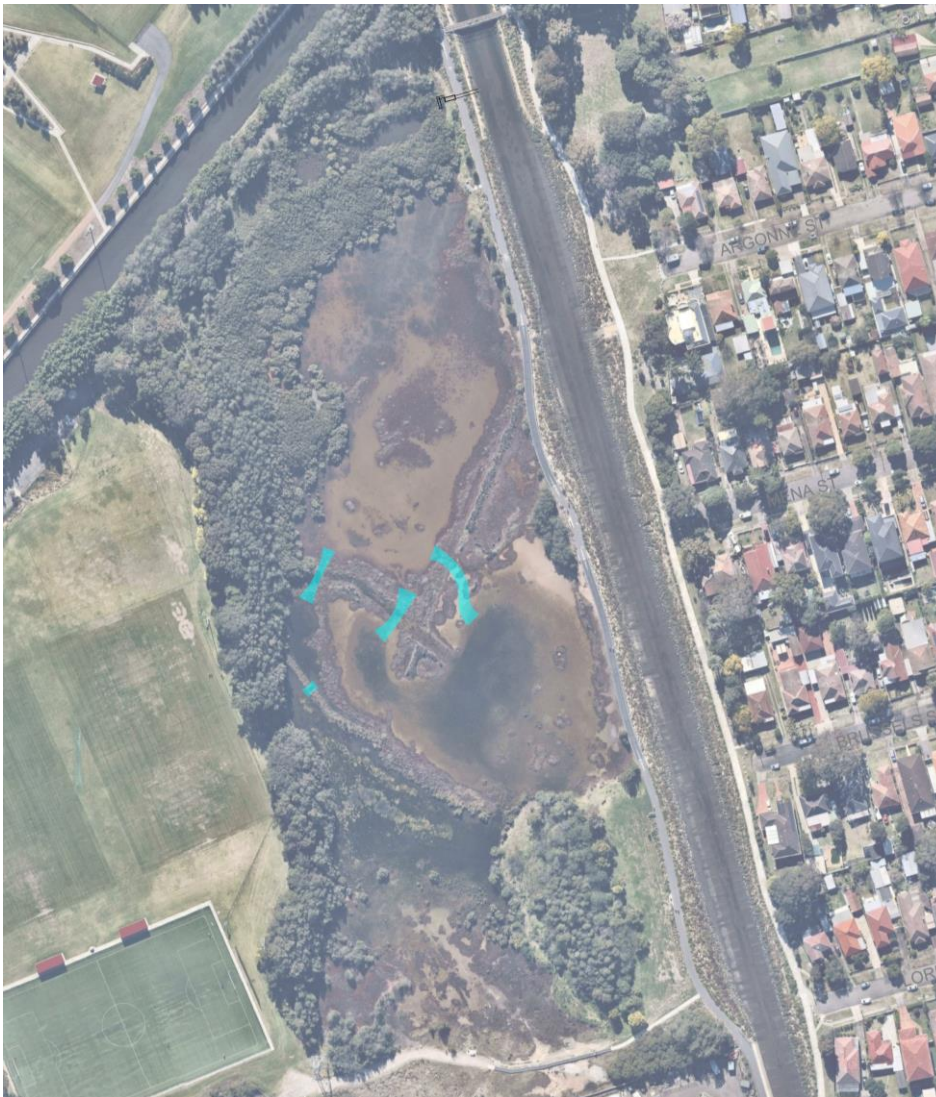
Figure 22 Key locations for possible hydraulic link embellishment

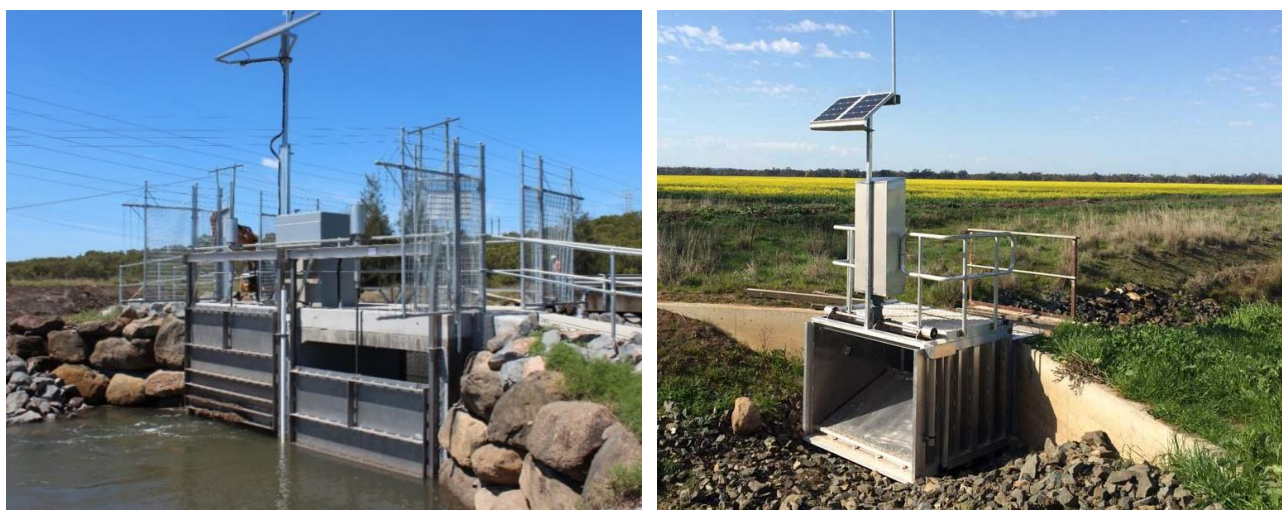
Figure 24 Example of automatic water control gate systems

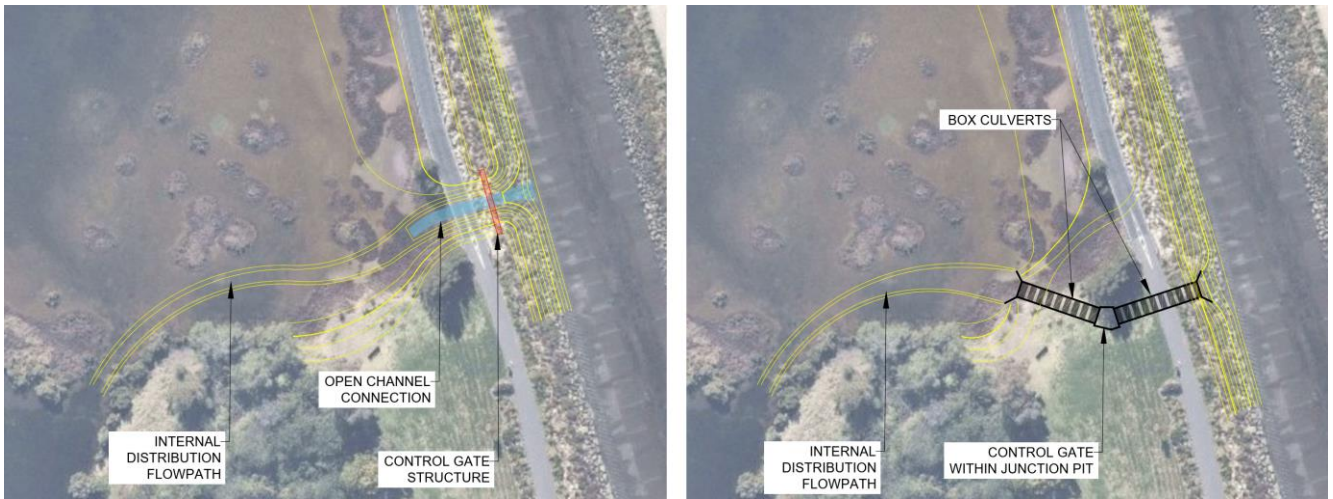
Figure 25 Indicative preliminary options for new inlet structure

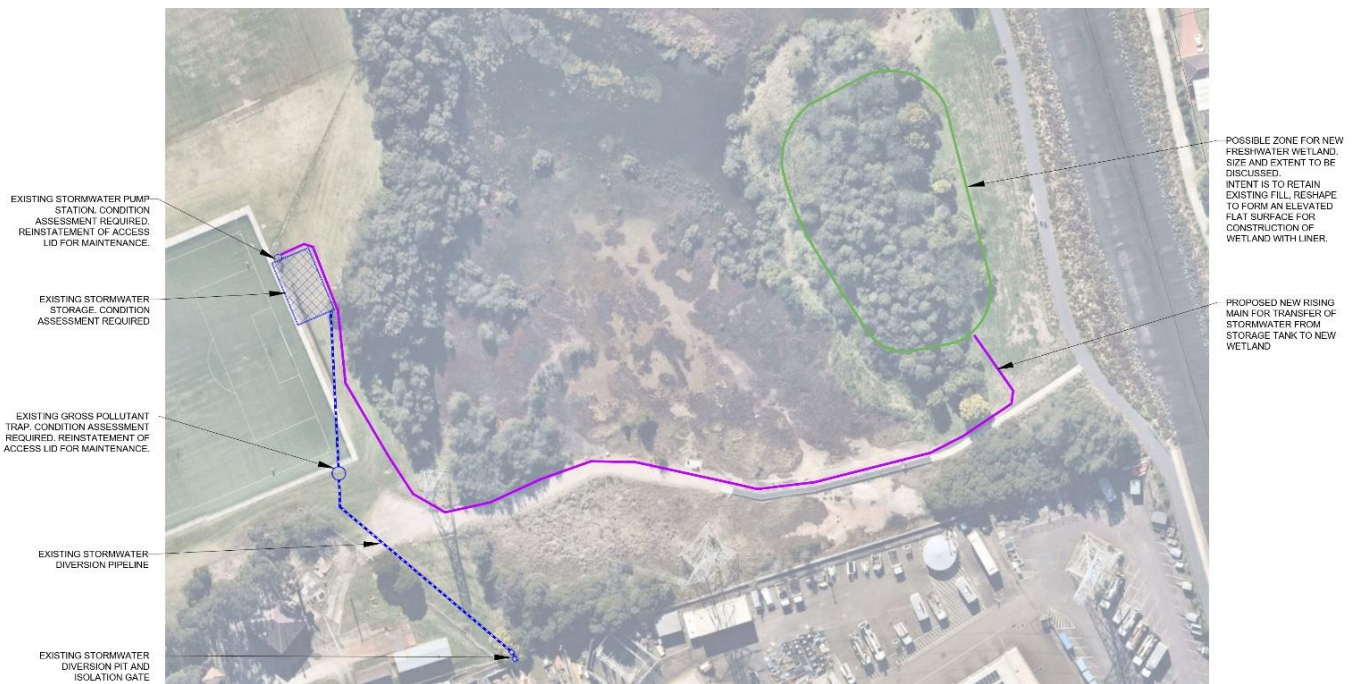
Figure 26 Indicative concept for new constructed freshwater wetland
